Grid ref: TM 19461 39061

EMBARKATION HARD CAT HOUSE, WOOLVERSTONE SITE N.K. TODAY

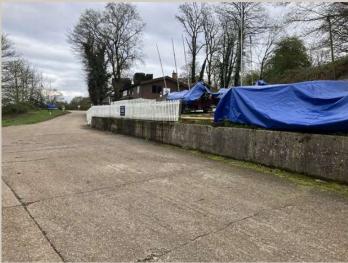
4. Re-enforced concrete circle turning offloading supplies

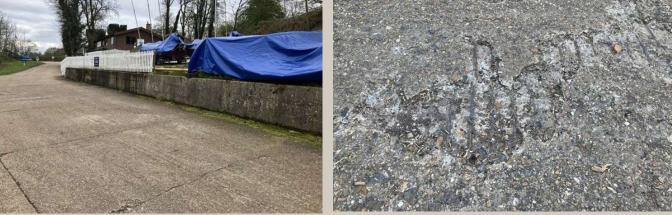
5. Re-enforced concrete apron, with retaining wall.

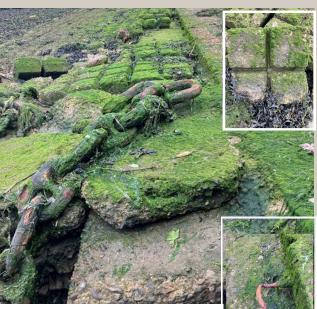
9. The apron measures 64m (70yds) in total width. It varies in depth between 13.8 m (15 yds) and 16.5 m (18 yds). Total area of apron is $960 \text{ m}^2 (1050 \text{ yd}^2)$.

Some remains of the metal hooks to secure this can still be seen.

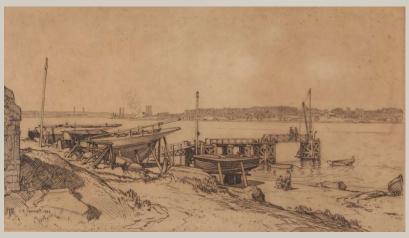
12. The jetty we see today is not the original. This pencil sketch by Leonard Squirrell in 1949 shows the heavily structured wooden dolphins. However, the stumps showing above the mud are likely the remains of the original dolphins.
